# Manhole Inspection Summary

# Manhole # S39CC\_014MH

Insp Date: **12/11/07 12:36 PM**

**Location** Address: **1000 bldg ashland ct**

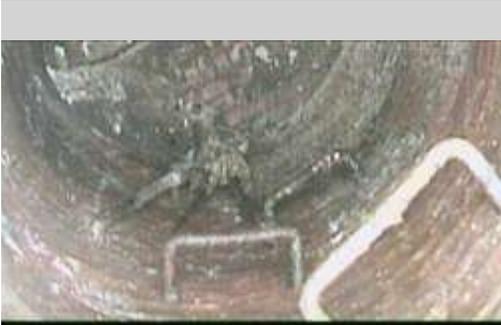
Defect 2

**Corroded**

steps

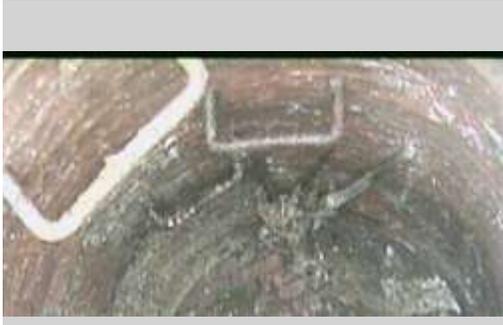
Defect 1

**Evidence Of Surcharge**

Depth: **4**

evidence of surcharge

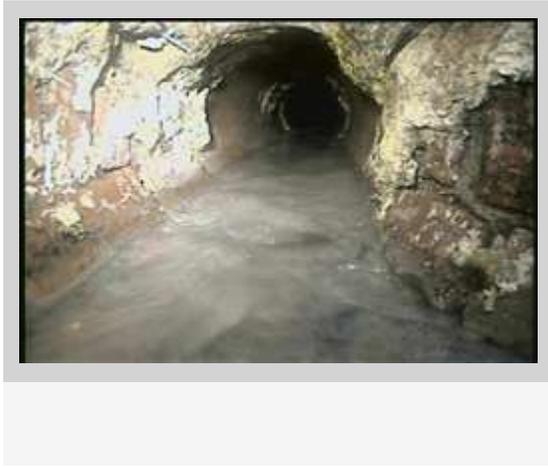
**12 O'Clock Outflow**

**8 in. Circular Gravity Sewer**  
**Pipe Out @ 12 O'Clock**

Invert Depth: **8.80** (ft.) Flow Characteristics: **Slow**

Infiltration: **None** Pipe Seal Cond: **Unknown**

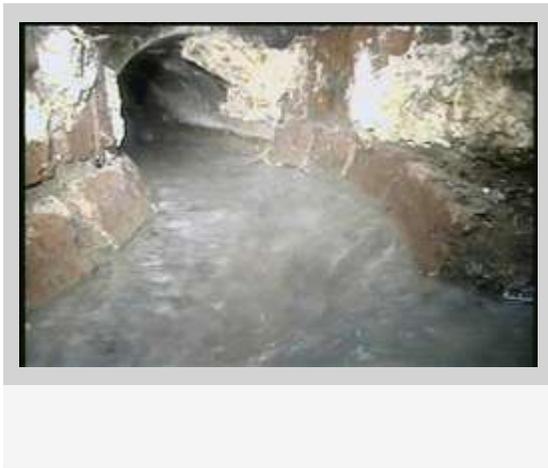
**3 O'Clock Inflow**

**8 in. Circular Gravity Sewer**  
**Pipe In @ 3 O'Clock**

Invert Depth: **8.70** (ft.) Flow Characteristics: **Slow**

Infiltration: **None** Pipe Seal Cond: **Unknown**

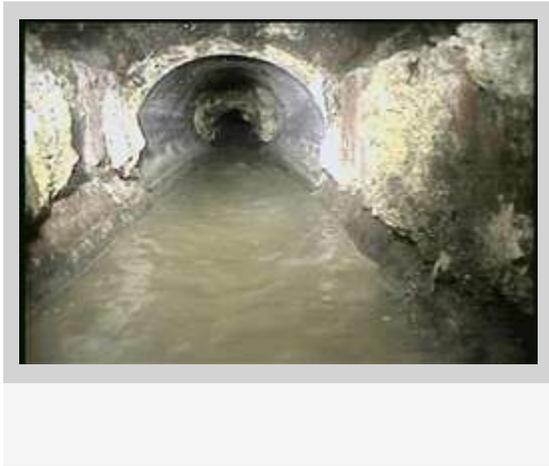
6 O'Clock Inflow

8 in. Circular Gravity Sewer  
Pipe In @ 6 O'Clock

Invert Depth: **8.75** (ft.) Flow Characteristics: **Slow**

Infiltration: **None** Pipe Seal Cond: **Unknown**
